## 7. フィリピンにおけるセミナー

(2) 「安全なコンクリートホローブロック造」プロジェクトの背景、目的及び概要

#### Background, Objective and Outline of Project for **Safer Concrete Hollow Block Structure in the Philippines** based on Japanese Experience and Technology

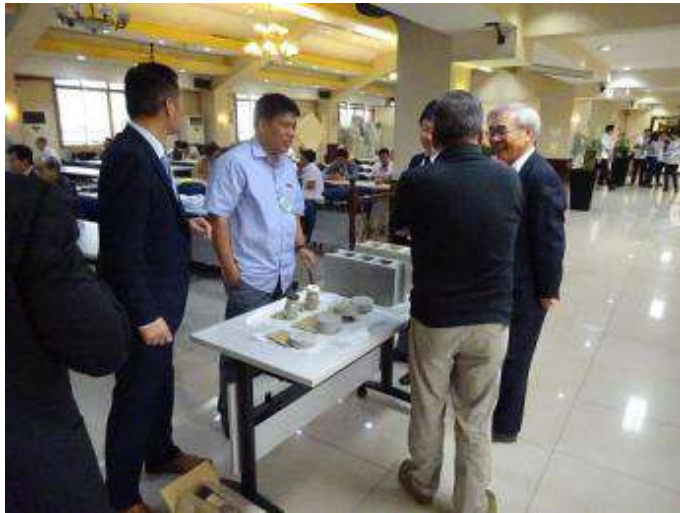
日本から持参したコンクリートブロックと各種のカットサンプルの展示

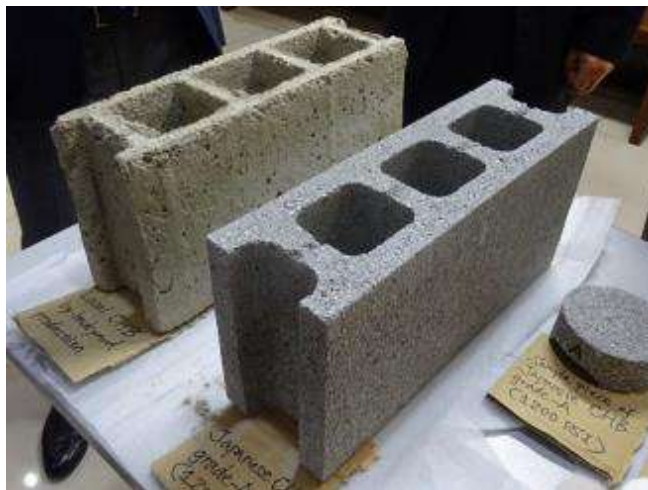
日本製のブロック（右）とフィリピンの小規模メーカーのブロック（左）

左は、手で触れただけで崩れたり、破損し破片が飛び散る。

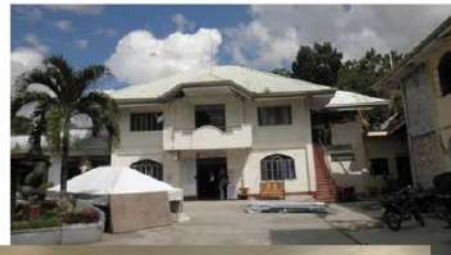
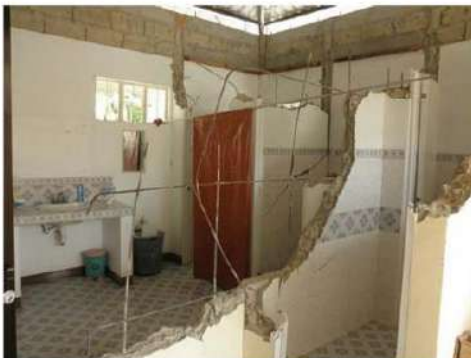
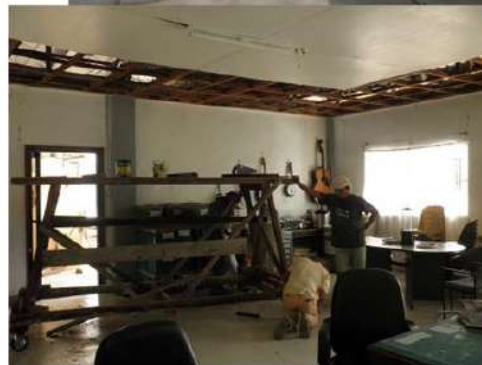
### Example to Municipal office of Antequera

No damage in structural members  
Serious damages in **non-structural walls and ceiling boards** on the second floor

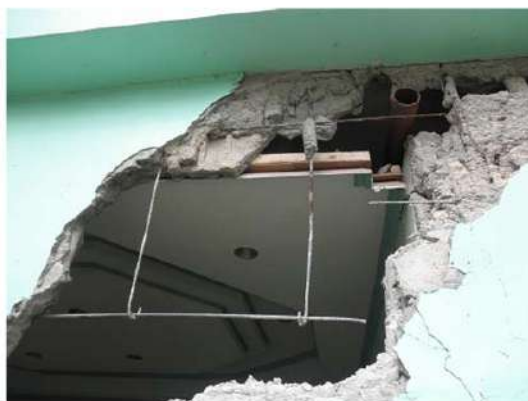
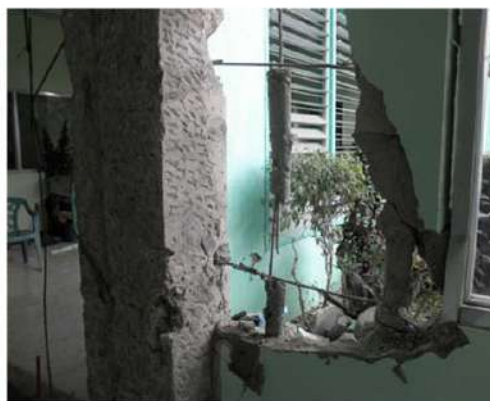
### Examples of to Municipal Office of Catigbian non structural walls

- Poor/insufficient quality of concrete hollow blocks
- insufficient compaction of mortal in bonds and hollows
- improper connection of rebar

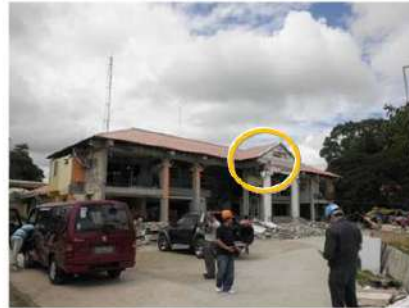
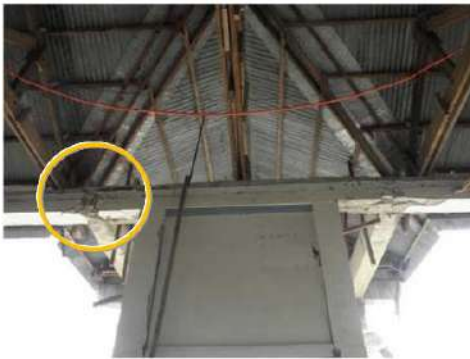
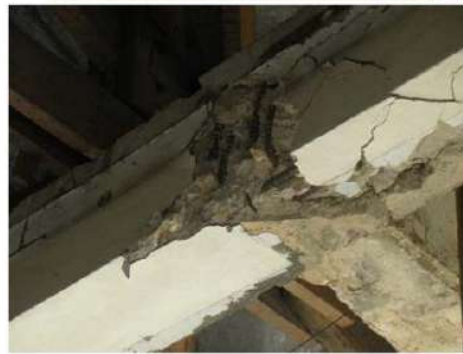
Municipal Government  
Office of Sagbayan

- Un-continuous type of beam

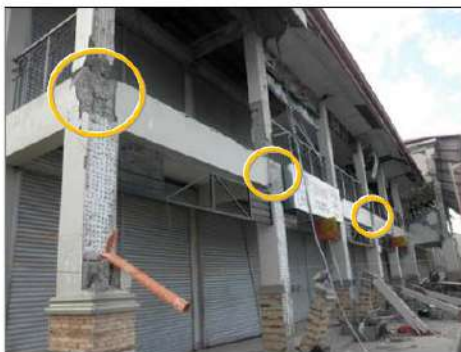
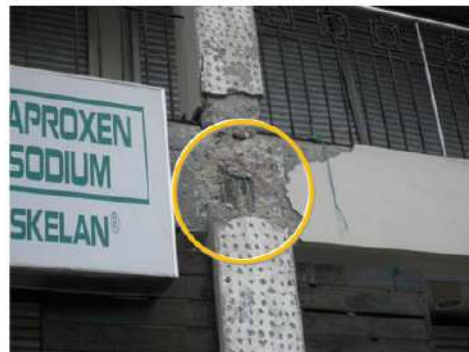
## Structural members Columns and beams Market building of Loon

- Small dimension of panels (crossing part of beams and columns)
- No hoops in the panels

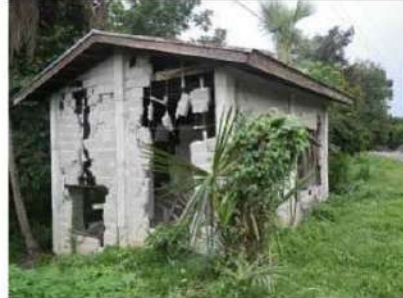
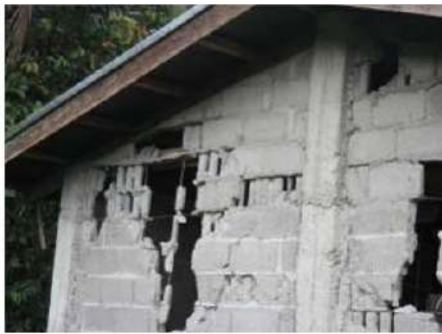
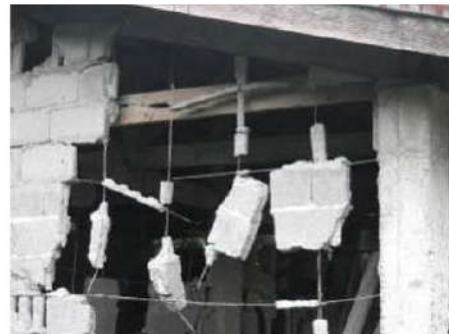
#### **Reinforced concrete hollow block house**

- Heavy damage because of poor quality of block, insufficient compaction of mortar and poor quality and improper connection of rebar

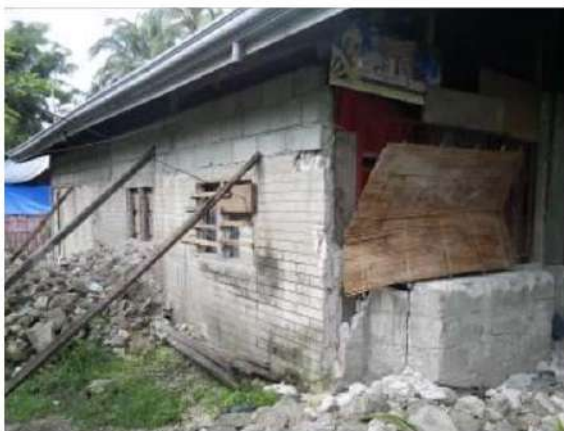
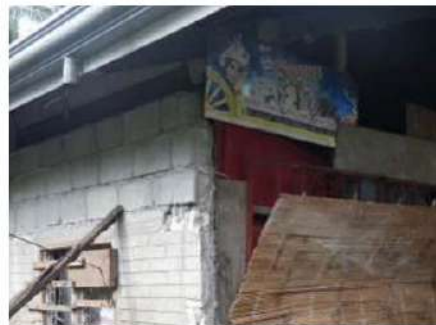
#### **Non-reinforced concrete block house**

- Separation of walls at corner caused the collapse of the house, which is one of most vulnerable part of masonry structures

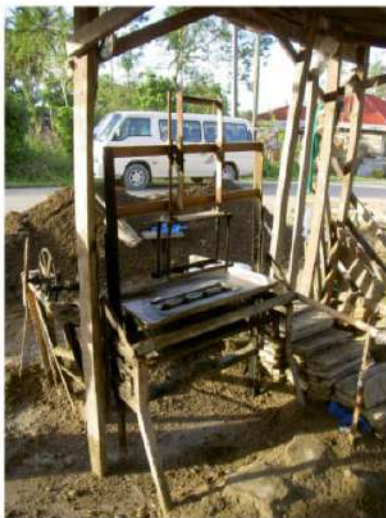
Poor quality of concrete block manufactured by small/family industry with poor quality control

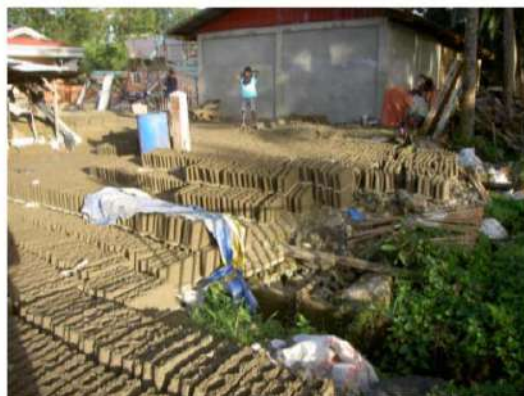
Poor ratio of cement, no curing after casting and so on

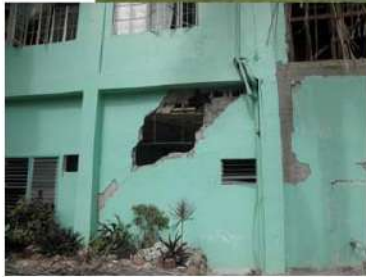
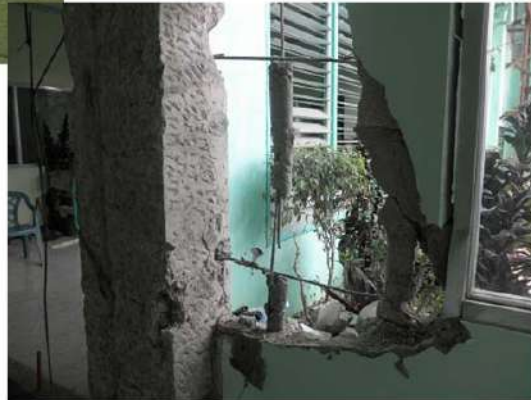
Poor impaction of filler mortar,  
not connected together well and  
broken into pieces

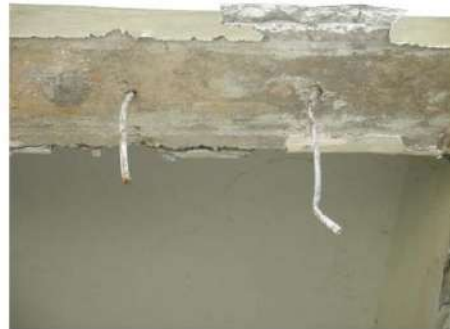
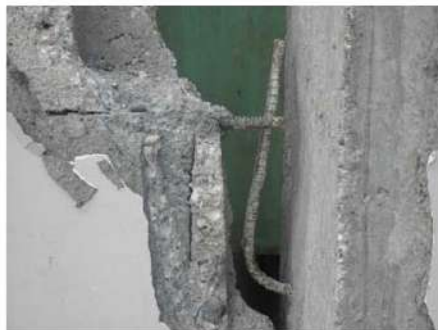
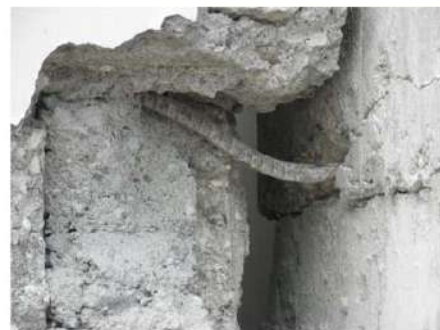
## Identified problems

Inappropriate connection/anchor of  
CHB walls to structural members  
(CHB in Market in Loon)

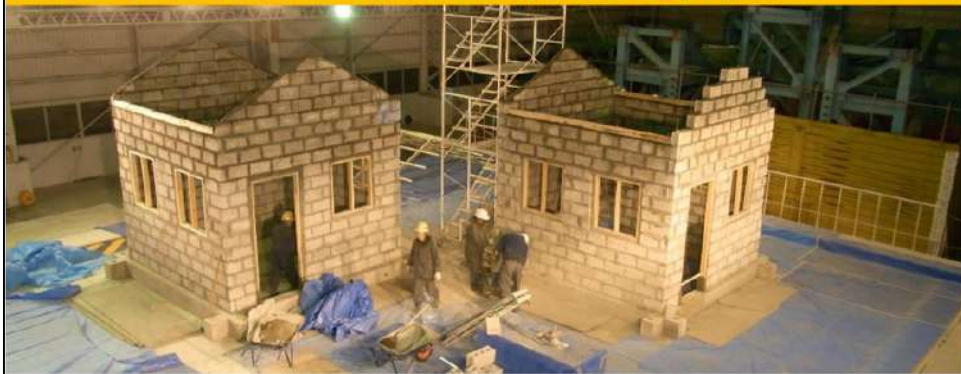
## ■ Full Scale Shaking Table Test

Though “**FULL SCALE SHAKING TABLE TEST OF PHILIPPINE CHB MASONRY HOUSES**” as comparison study, we figure out behavior during earthquake, and seismic performance of ordinary houses.

For the dissemination of Earthquake safe houses in the Philippines, we are planning to develop **Simple Seismic Evaluation method** and **Awareness tools** in the project.

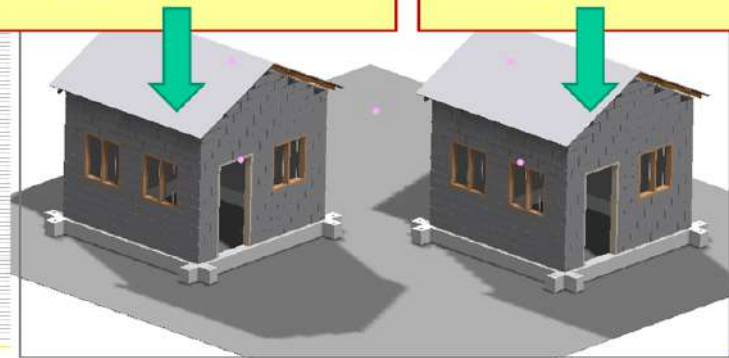
### **MODEL B : Non-Engineered model**

(Typical field construction model, not following BC)

Wall : CHB 4" (400x200x100)  
Vertical bar : 6mm@900  
Horizontal bar : 6mm@600  
Joint Mortar : 1 : 4

### **MODEL A : Engineered model**

(Following Building code)

Wall : CHB 6" (400x200x150)  
Vertical bar : D10mm@400  
Horizontal bar : D10mm@600  
Joint Mortar : 1 : 4

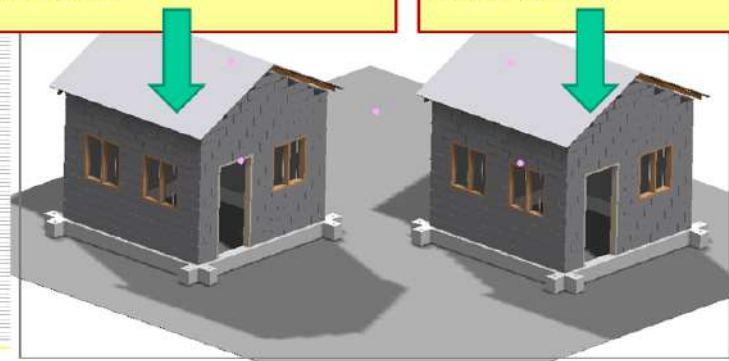
### MODEL B : Non-Engineered model

(Typical field construction model, not following BC)

Wall : CHB 4" (400x200x100)

Vertical bar : 6mm@900

Horizontal bar : 6mm@600

Joint Mortar : 1:4

### MODEL A : Engineered model

(Following Building code)

Wall : CHB 6" (400x200x150)

Vertical bar : D10mm@400

Horizontal bar : D10mm@600

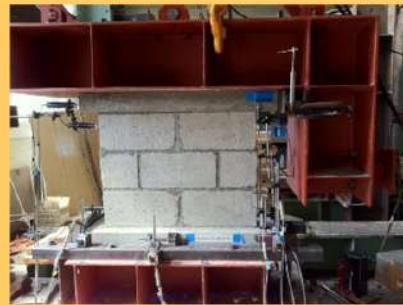
## Shear strength CHB masonry Prism – wall unit

6 inch (150mm)		Longitudinal bar		
		D10	D6	none
Mortar	1 : 4	6" 4 D10 <small>Model A 07 Feb 2011</small>	6" 4 D6	6" 4 N
	1 : 8	6" 8 D10		
	1 : 4	6" 4N D10		6" 4N N
	Bad fill			○、△

Effectiveness of mortar and proper construction

Effectiveness  
of Steel bar

4 インチ (100mm)		Longitudinal bar		
		D10	D6	none
Mortar	1 : 4	4" 4 D10 ○	4" 4 D6 ○	4" 4 N ○、△
	1 : 8			
	1 : 4		4" 4N D6	4" 4N N
	Bad fill		<small>Model B 07 Feb 2011</small>	○、△

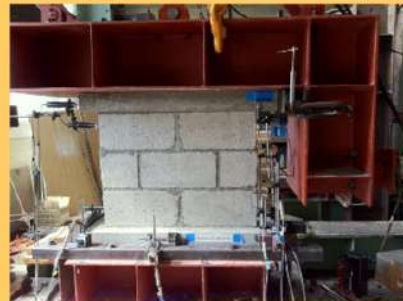
## Shear strength CHB masonry Prism – wall unit

6 inch (150mm)		Longitudinal bar		
		D10	D6	none
Mortar	1 : 4	6" 4 D10 <small>Model A 07 Feb 2011</small>	6" 4 D6	6" 4 N
	1 : 8	6" 8 D10		
	1 : 4	6" 4N D10		6" 4N N
	Bad fill			○、△

Effectiveness of mortar and proper construction

Effectiveness  
of Steel bar

4 インチ (100mm)		Longitudinal bar		
		D10	D6	none
Mortar	1 : 4	4" 4 D10 ○	4" 4 D6 ○	4" 4 N ○、△
	1 : 8			
	1 : 4		4" 4N D6	4" 4N N
	Bad fill		<small>Model B 07 Feb 2011</small>	○、△

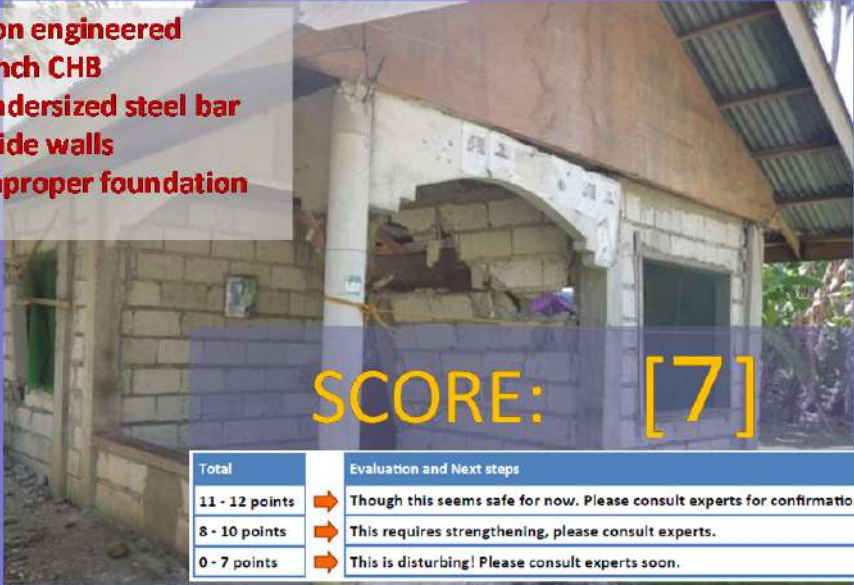
■ **Test for 12 questions** in Bohol Earthquake, October 15<sup>th</sup> 2013

- **Non engineered**
- **4inch CHB**
- **Undersized steel bar**
- **Wide walls**
- **Improper foundation**

**SCORE: [7]**

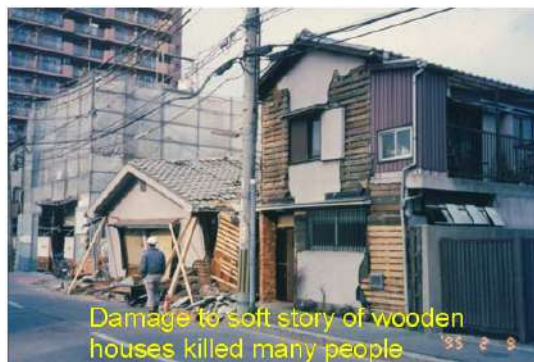
Damage to soft story of wooden houses killed many people

- 1995 Hyogo-ken Nanbu EQ (M=7.2) → extensive damage
  - 6,460 deaths
  - 40,000 injuries
  - More than 240,000 total/partial collapse
  - More than 6,000 destroyed by fire
- Seismic evaluation and retrofitting were applied to existing buildings built before the new seismic design method
- Seismic Retrofitting Promotion Law enforced since 1995
- Damage to buildings after the new design method mainly due to soft and weak story → Revision of shape factor

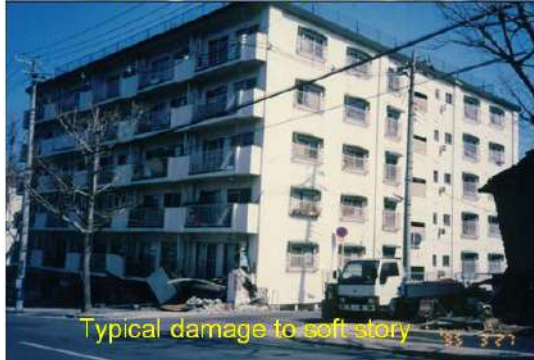
Typical damage to soft story

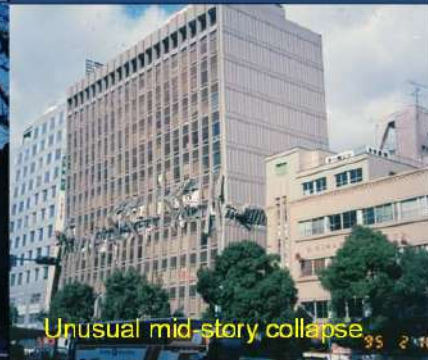
Unusual mid-story collapse

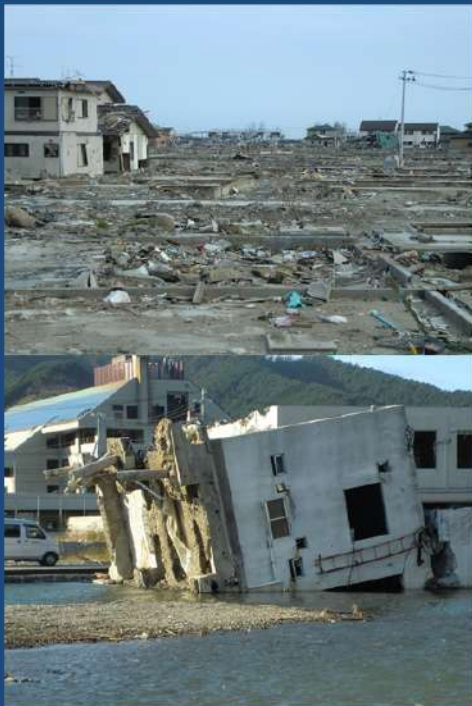
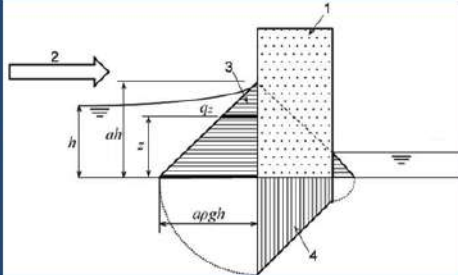
**Damage caused by tsunami & Notification for tsunami actions**

1 structure, 2 tsunami direction, 3 horizontal hydrostatic force, 4 vertical hydrostatic force (buoyancy),  $a$ : water depth factor,  $h$ : inundation depth

- Huge EQ (M=9.0) → huge damage
  - 16,000 deaths and 2,500 missing
  - Max tsunami run-up height 40.1m
  - More than 120,000 total collapse
- Damage to building is mainly caused by tsunami. No major revision to seismic code for buildings.
- Notification for large-scale ceilings and Notification of tsunami for buildings that should resist tsunami actions.
- Damage to nuclear power plants.

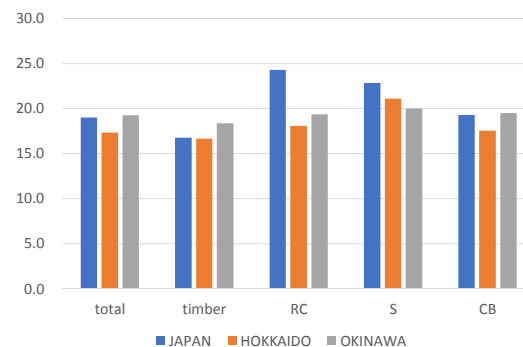
## 2.3 Construction status – cost –

- JAPAN : timber is lowest. CB is 15% higher, RC 45%, Steel 36%.
- OKINAWA : timber is higher than JAPAN average. CB is 6% higher.
- HOKKAIDO : each structure is lower than JAPAN average. Timber is same as JAPAN average. CB is 5% higher than timber.

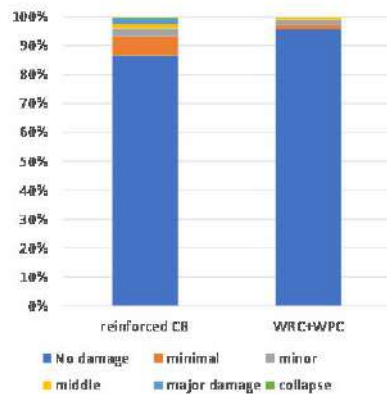
- No damage and minimal damage were more than 90% in intensity 7 area of Great Hanshin-Awaji.
- Damage level was almost same as RC wall system buildings.

Damage ratio of reinforced CB and RC in intensity 7 area of Great Hanshin-Awaji

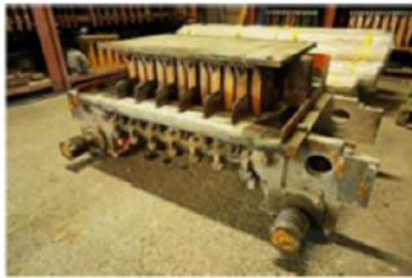
Mold Box

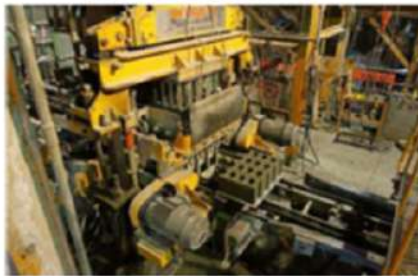
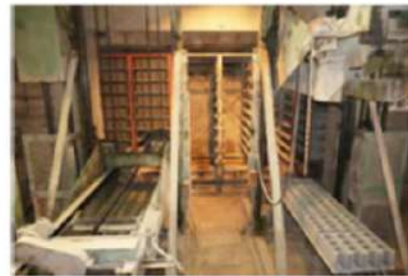
Block Forming Machine

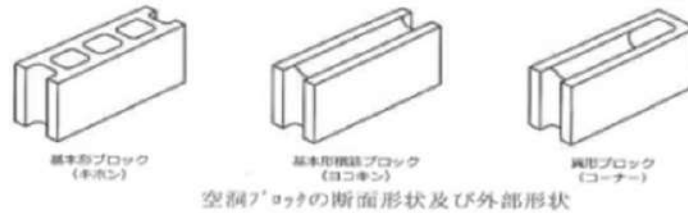
## External shape

Type		Compressive strength		Water absorption Rate
断面形状による区分	圧縮強さによる区分	圧縮強さ (1) (N/mm <sup>2</sup> )	全断面積圧縮強さ (2) (N/mm <sup>2</sup> )	質量吸水率 (%)
空洞ブロック	08 (A)	8以上	4以上	30以下
	12 (B)	12以上	6以上	20以下
	16 (C)	16以上	8以上	10以下

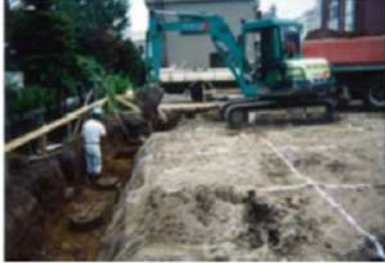
Piling work and digging the ground

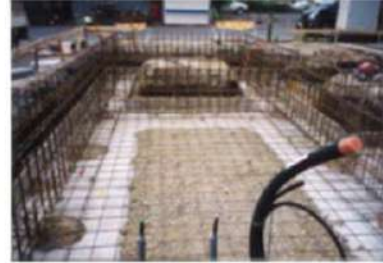
Placement of rebar for foundation

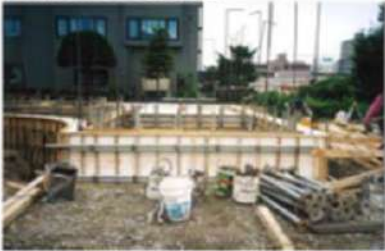
Formwork for foundation

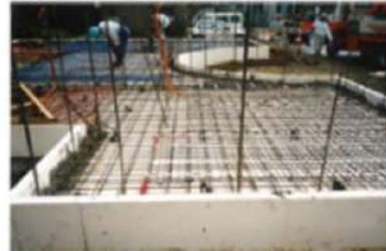
Concrete reinforcing bar arrangement

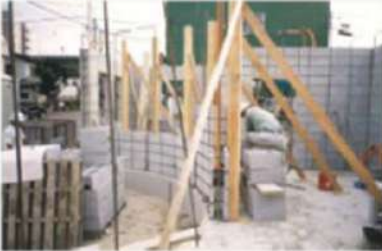
Loading work of blocks

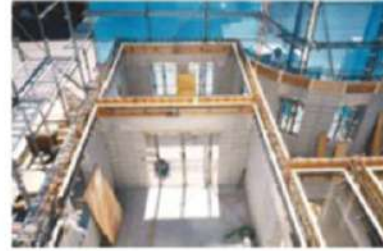
Beam formwork

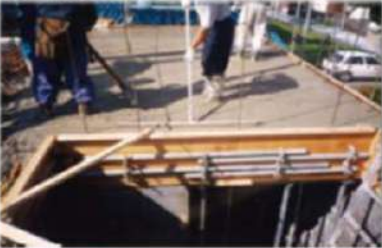
Leveling concrete on the second floor

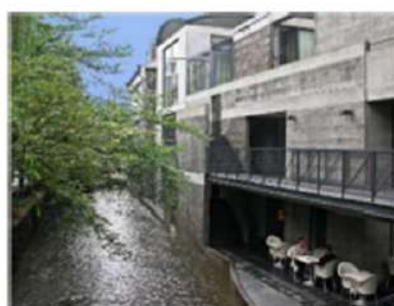
- Reinforced Fully Grouted Concrete Masonry Structure can use for higher floor height or underground structures.

Reinforced Fully Grouted Concrete Masonry Structure by Tadao ANDO (1984, 91)

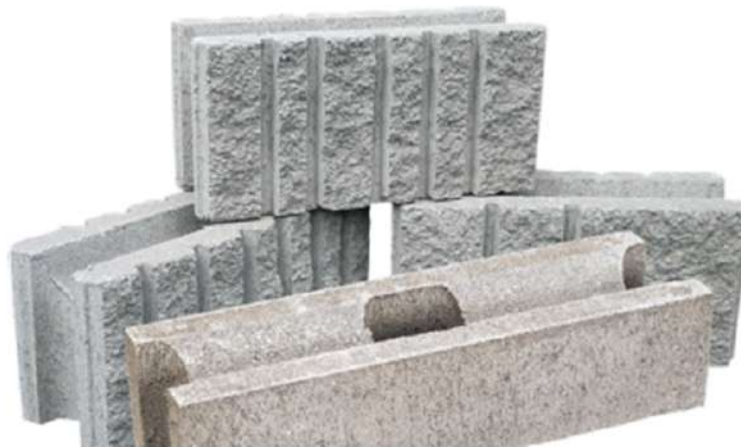
## 5. Optional trial processed block

- Colored or textured block has been produced since around 1970s.
- Block has potential to offer variable texture.
